Evaluation of Failure in Low k Films Using Stiffness Mapping and Dynamic Imaging

This article presents the use of dynamic imaging and stiffness mapping on low k materials for analyzing crack lengths in the measurement of fracture toughness and for determining the “finger prints” of failure during scratch testing.

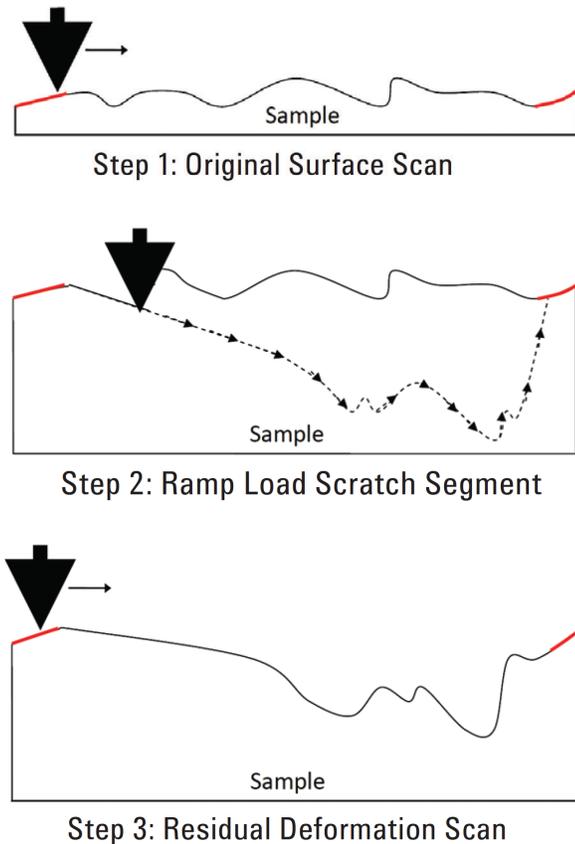
a pre-scan and a post-scan, usually equal to 10% or 20% of the scratch length, is performed so that the software can automatically align the data in the three steps. The original and residual single-line scans allow for the evaluation of deformation mechanisms and the quantification of deformation. The scratch process is diagrammed in Figure 1.

Ramp-load scratch testing was also conducted using a cube-corner tip. In a ramp-load scratch test, the tip is brought into contact with the sample; then, the tip is loaded at a constant loading rate while simultaneously translating the sample. Prior to and following the scratch test, a single-line-scan of the surface topography is completed for comparing the original surface to the deformation caused by the scratch test. Therefore, each scratch test consists of three steps: a single-line pre-scan of the area to be scratched, the ramp load scratch test, and a final scan to evaluate the residual deformation. Before and after each step,

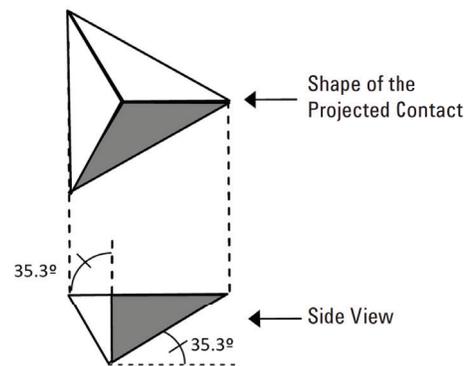
Figure 2. Diagram of cube corner tip.

The tip chosen for conducting the scratch tests was a cube-corner tip with a tip radius that was, nominally, less than 50nm. A cube-corner tip creates a triangular projected contact with the sample; this tip geometry creates high levels of stress in the material during the scratch. Scratches can be performed either face-forward or edge-forward when using a pyramid shaped indenter. Scratching face-forward with the cube-corner tip acts

like a snow plow and pushes the material out of the way, while edge-forward cuts the material like a knife. A diagram of a cube-corner tip is shown in Figure 2. The low k samples were tested using the cube-corner tip positioned so that it scratched face-forward.

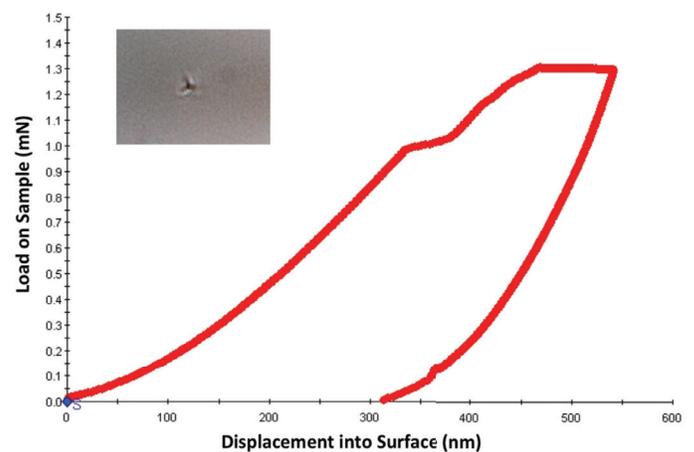
Figure 3. Load-displacement curve of an indentation performed on the low k film to introduce cracking. The residual impression is displayed in the upper-left (1000X magnification).

Fractures were created in the low k film using a cube-corner indentation tip and performing a quasi-static indentation test up to 1.3mN of force. Fracture of the film can be seen in the load versus displacement curve shown in Figure 3 when the load reached a value of 0.99mN. These cracks continued to propagate as the sample was loaded to 1.3mN—small signs of continued fracture were apparent at forces of 1.16mN and 1.26mN. The residual microscope image, at 1000X magnification, of the indentation test is shown in the upper left corner of Figure 3. While small cracks are apparent, measurements of the crack lengths would not be possible. Therefore, dynamic imaging of the residual indentation was performed to provide a means for measuring the crack lengths in the material without having to transfer the sample to another instrument, such as a scanning electron microscope, for imaging.

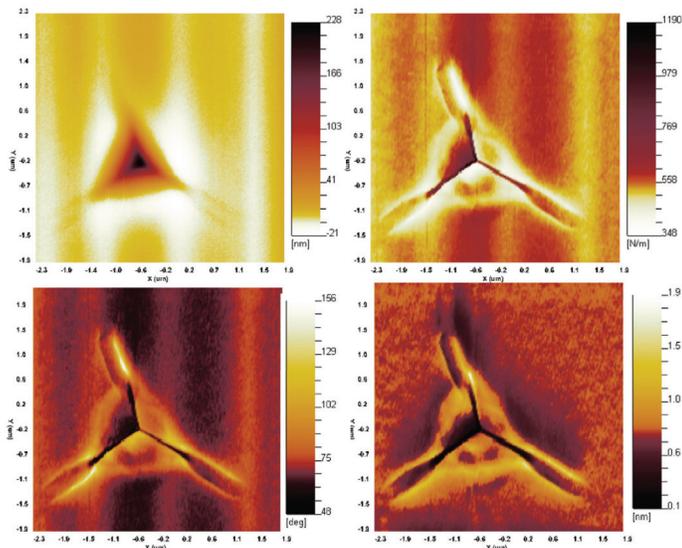
Figure 4. Topography (upper left), stiffness (upper right), phase angle (lower left), and harmonic displacement (lower right) maps of the residual impression left from the indentation test performed in Figure 3. (4.2µm scan)

One dynamic scan provided the necessary data to produce topography, stiffness, phase angle and harmonic displacement maps of the residual indentation; the four maps are all shown in Figure 4. The topographic map showed evidence of fracture; however, the crack lengths were unclear due to the poor contrast between the large displacement range used in scanning the indent and the small scale displacements seen in fracture. Stiffness, on the other hand, showed much more contrast because only small stiffness changes were apparent due to topographic changes; but, when cracked or blistered material

was encountered, the stiffness changed dramatically. During scanning, when the tip falls into a crack or a sharp edge impression, the contact area increases abruptly and a large stiffness is detected. When the tip has just been removed from a crack or blistered section of the film, the stiffness decreases abruptly due to the limited support of the surrounding material. Dynamic imaging takes advantage of the contrast created when abrupt changes in contact areas are detected. Figure 4 shows that the stiffness and phase angle maps provided the best contrast for measuring the crack lengths. The harmonic displacement map was not used in measuring the crack length because a short lag in harmonic displacement control was apparent after scanning the top crack.

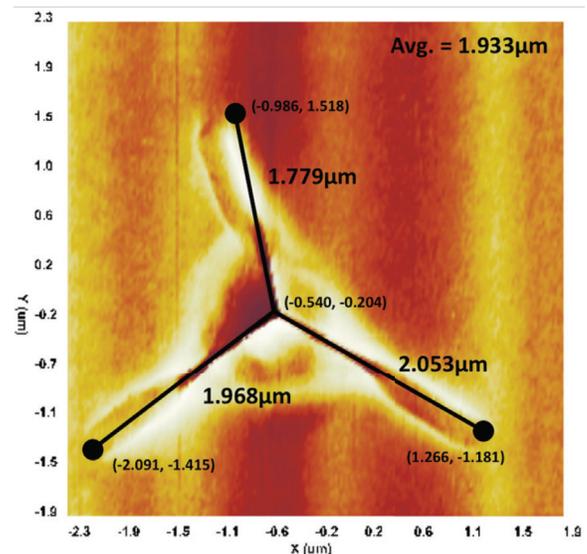
Figure 5. Crack length measurements using the stiffness map produced via dynamic imaging.

Each crack was measured using the stiffness map in Figure 5 and an average crack length of 1.933µm was determined. A first order approximation of the fracture toughness can be determined using the elastic modulus (E) and hardness (H) of the film along with the maximum load (P) and crack length (c) from an indentation test with a cube-corner tip using the relationship in Equation 1.1.

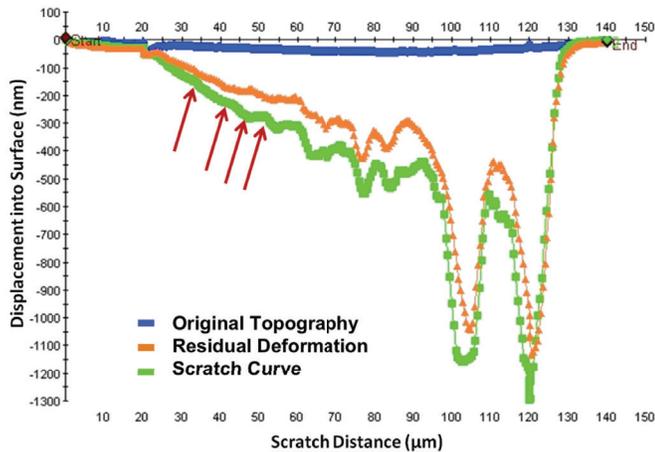
Figure 6. The scratch results (original topography, scratch cycle, and residual deformation) from a typical ramp-load scratch test on the low k film using a maximum force of 1mN. Arrows indicate failure in the film.

Scratch testing was conducted on the low k film to better understand failure modes of the film and to better understand separation of the film from the substrate. A ramp-load scratch test to a maximum load of 1mN was used to conduct 100 μm -long scratches. In examination of the resulting scratch curves, multiple points of failure were apparent—the scratch curves for a typical test are shown in Figure 6 with arrows indicating the locations of multiple failure points and possible locations of interface failure. Figure 6 also shows the scans of the original topography (blue), scratch cycle (green), and the residual scan (orange). There was a significant amount of plastic deformation observed in the scratch curves—plastic deformation is depicted by the area between the original topography and the residual deformation, while elastic deformation is depicted by the area between the residual deformation and the scratch cycle—leading up to failure. However, there was insufficient information in the data to decouple deformation mechanisms such as plastic deformation, blistering, and chipping; dynamic imaging of the failure region was used to decouple the three deformation mechanisms and correlate the results to the scratch curves.

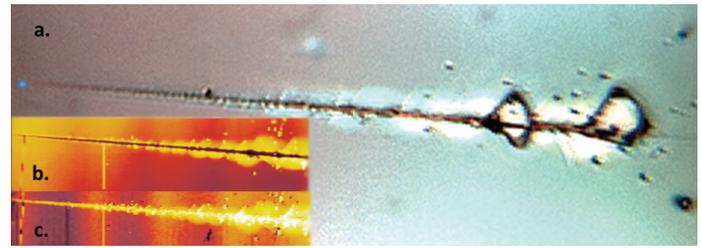
Figure 7. Microscope image (a.) of the residual scratch at 1000X magnification aligned with the topography scan (b.) and the stiffness map (c.) of the region of failure.

In Figure 7, the topography scan and stiffness map of the failure region are shown aligned with the microscope image of the residual scratch taken at 1000X magnification; this figure shows that failure of the low k film occurs far before it can be observed in the microscope image. The topography and stiffness maps are shown in greater detail in Figure 8. While the topographical image shows early failure of the film, this failure is dominated by minor pile-up and possibly chipping, which does not classify as interfacial failure. By examination of the stiffness map, clear blistering does not start until a scratch distance of $52 \mu\text{m}$ is reached; this region is indicated on the stiffness map in Figure 8. Blistering was determined from the stiffness map when the area surrounding the scratch path showed clear radial propagation of low stiffness signifying that the area has separated from other material in the system and was not well supported. The critical load, defined as the first location of delamination or blistering, was located at this point. Figure 9 shows the stiffness map aligned with the scratch data and an arrow indicating the critical load point in the 2D scratch curves.

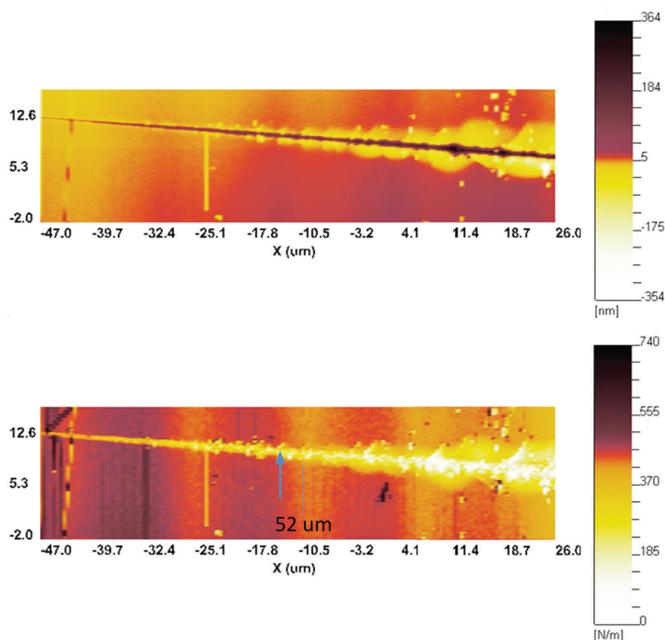
Figure 8. Topography and stiffness maps of the failure region.

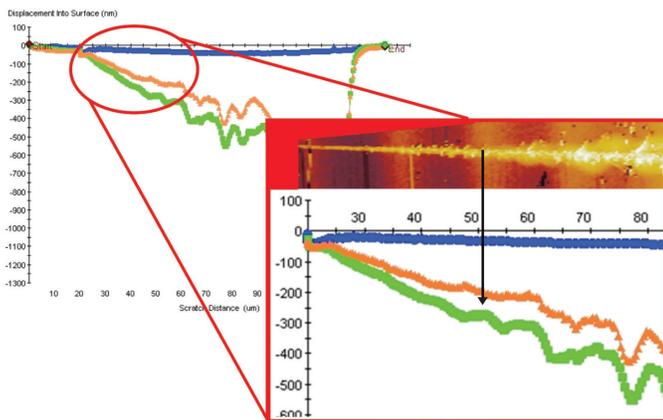
Figure 9. Scratch curves with an outset of the curves aligned with the stiffness map. The arrow locates the finger print of failure that indicates major failure of the film.

With the examination of the “finger prints” of failure in the scratch curves, the other scratch data on similar samples were analyzed without the need for imaging. Figure 9 shows that the scratch curve may possess dithers that represent minor chipping of the film—at scratch distances of $35 \mu\text{m}$ and $42 \mu\text{m}$ there are noticeable events that occur in the scratch curves—but an arrest of the penetration rate followed by an abrupt acceleration of penetration represented major failure of delamination or blistering in this sample. From analysis of all tests performed on this sample, failure, defined by blistering or delamination, occurred at a normal force of $0.260 \pm 0.03 \text{ mN}$.
